## Chapter 6    **GEOPHYSICAL INVESTIGATIONS; NORTH AND SOUTH PENDER ISLANDS**

### 6.1    **Introduction**

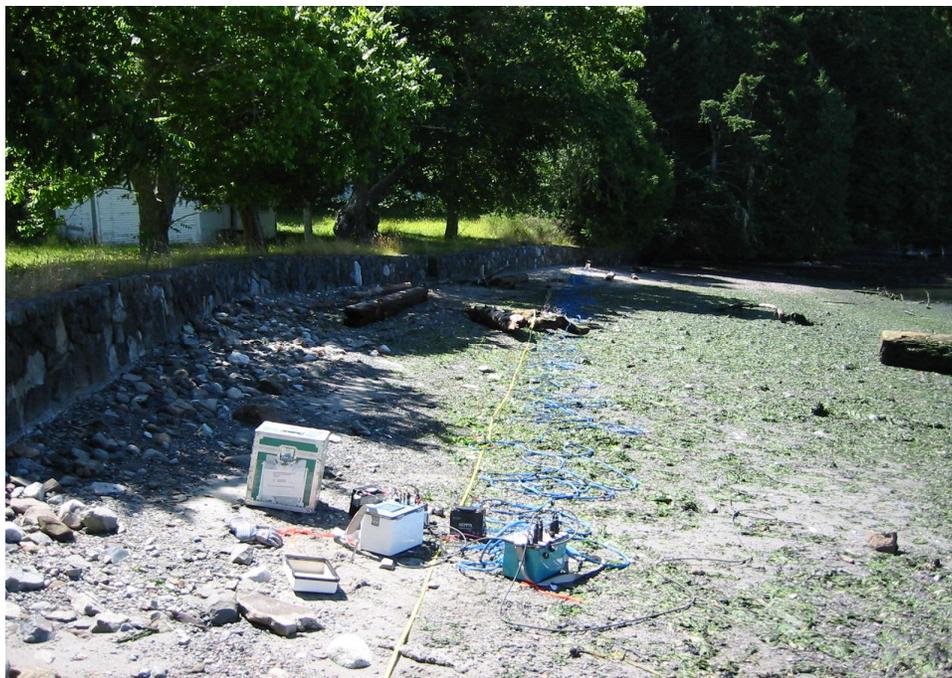
Figure 6.4: Electrical imaging survey along the beach at Roes Island, North Pender Island Survey conducted along high tide line; sandstone of the Galiano Formation exposed in trees at far end of breakwall.

Line 2 is oriented in a west-east direction above the breakwall visible in Figure 6.4. The electrical imaging interpretation indicates that the near-surface sediments are either fine-grained or contain higher total dissolved solids in the groundwater (Figure 6.5). As mentioned previously, the area south of station 33 was saturated at the time of the survey and this area has the lowest measured resistivity values. Due to space constraints at the site, it was not possible to increase the electrode separation of the electrical imaging survey to investigate depths greater than 5.75 metres. The electrical imaging modeled response is presented in Appendix C (Figure C.5).

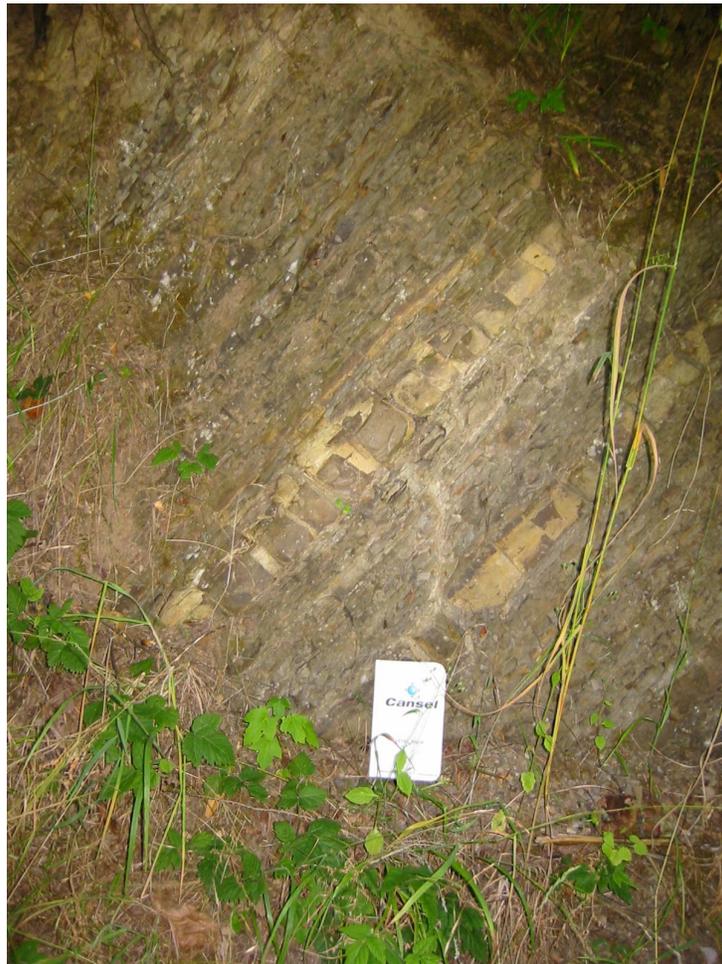
Figure 6.11: Outcrop of Northumberland Formation, Corbett Road, North Pender Island illustrating steeply dipping bedrock consisting of weathered shale with sandstone stringers.

The survey line along Corbett Road was oriented in an north-south direction and extended from a bedrock exposure in the road cut (Figure 6.11) down across a broad valley and up the east side of the valley (Figure 6.1a, Line E). The bedrock consists predominantly of shales of the Northumberland Formation with dips ranging from 40 to 45°. The survey line was oriented perpendicular to the known strike of the bedrock.

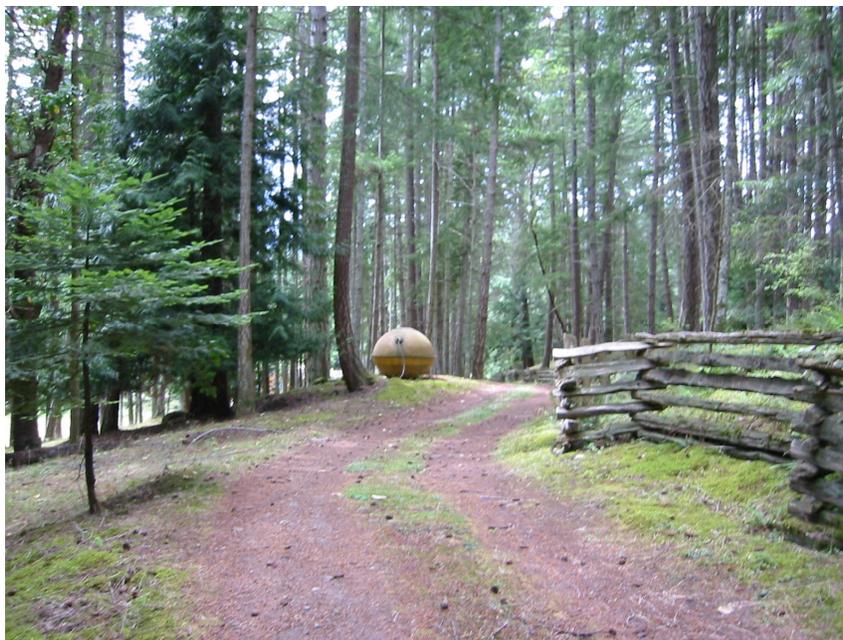
Figure 6.23: Storage tank to store water from the spring located on the Allison Farm, North Pender Island. Note the hose running along the left side of the road to the storage tank.

The spring provides a reliable source of water for the farm and residences on the property (H. Allison, personal communication, 2003). Efforts have been made to capture water from the spring. Figure 6.23 illustrates the storage tank for the spring water located approximately 80 metres west of the spring. A garden hose carries water from the spring to the storage tank (Figure 6.23). An overflow from the storage tank was the root cause of the water on surface at the time of the survey.

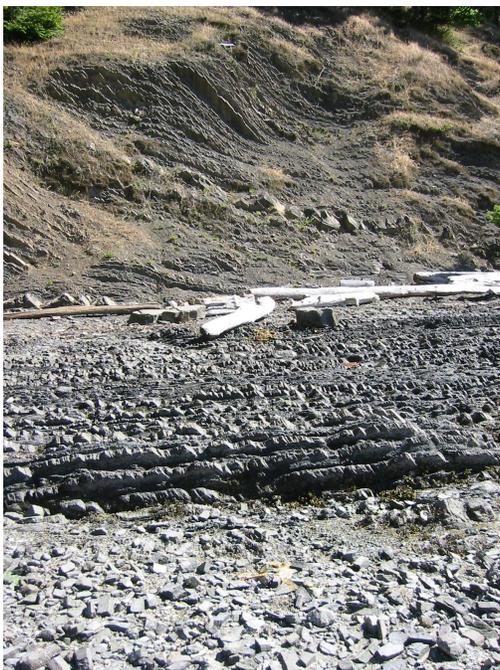
Figure 6.24: Cedar Formation shale outcrop, Medicine Beach, North Pender Island. Note the steeply dipping bedrock and the sandstone stingers present in the shale.

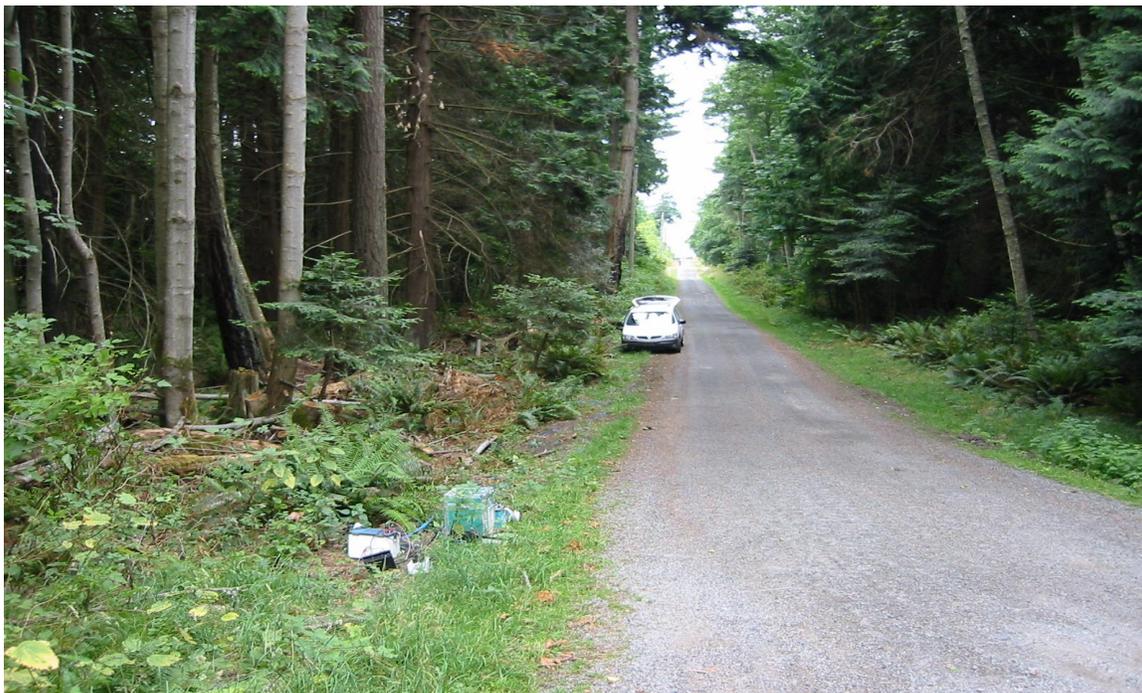
Figure 6.32: Electrical imaging instrumentation along Higgs Road, South Pender Island. The vegetation along the road side is indicative of a soil cover. At the far end of the road is the shoreline.

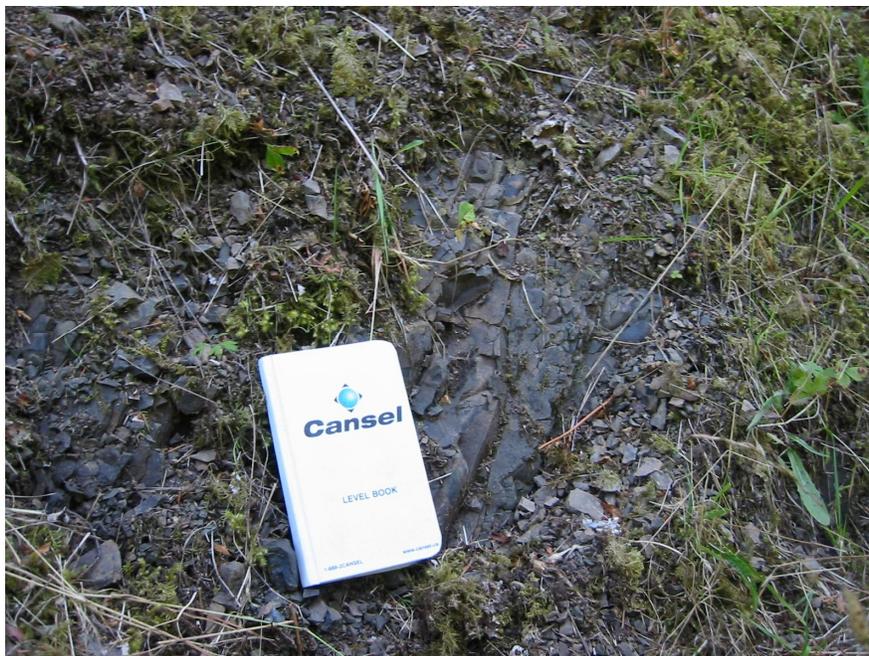
Figure 6.37: Bedrock outcrop, DeCourcy Formation, Canal Road, South Pender Island. Note the high degree of weathering of the bedrock, as well as the apparent steep dip.

A geophysical survey line was located along Canal Road (Figure 6.1b, Line P). The bedrock at this site consists of DeCourcy Formation sandstones with some shale. The bedrock dips between 80 and 90°. The survey line was oriented in a north-south direction, parallel to the known strike of the bedrock. A bedrock outcrop of predominantly weathered shale was observed during the geophysical surveys (Figure 6.37). The survey line is also located close to and parallel to the Pender Fault.
